Jack Phillips

128 Main Street Gore

Detailed Seismic Assessment (DSA)

GM Ref: J4726

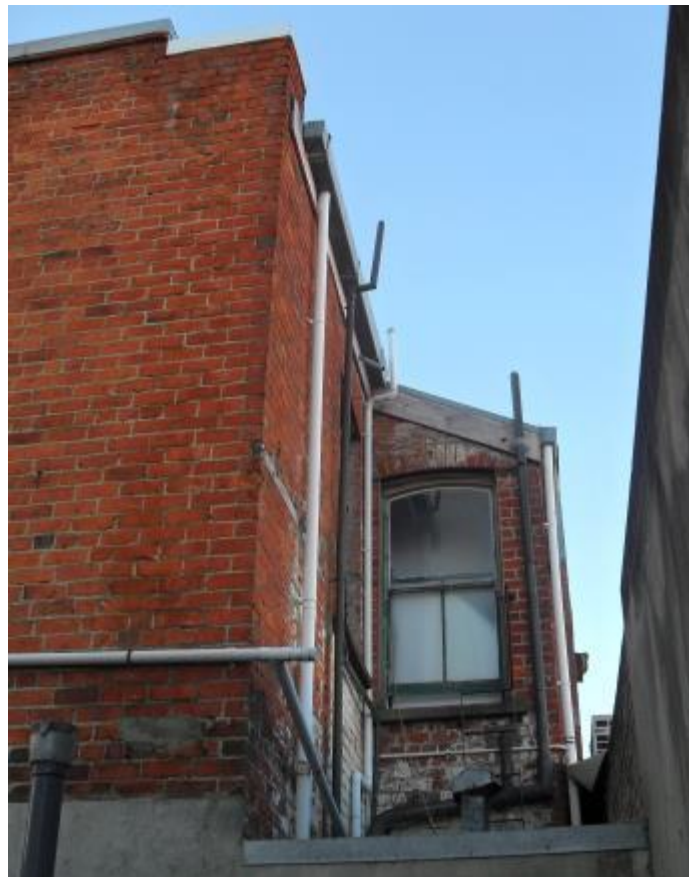
The building does not contain any lateral restraint mechanisms which would be adequate to resist a code earthquake event. The irregular shape of the structure would induce higher stresses in the areas of irregularity (at the acute corners) which would cause difficulty in restraining walls. This could possibly result in out of plane failure of various elements. A change in section is shown in Figure 1. A floor / roof diaphragm is the most economical way in which URM walls can be restrained from falling out of plane (outwards). It is therefore crucial to have regular ties at regular centres around the perimeter of the building. This becomes a difficult process when there are large windows and a change in plan regularity.

Figure 1 Change in shape of URM

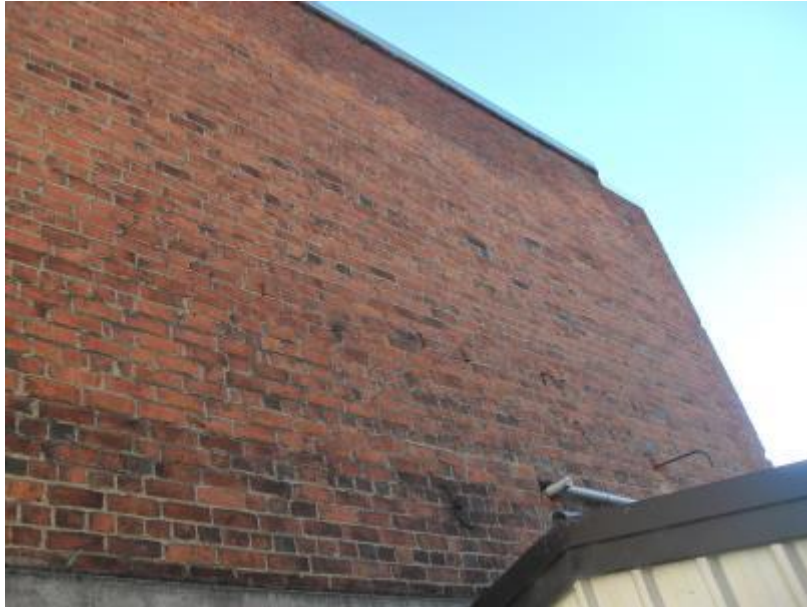
There has been extensive damage to the brickwork throughout as can be seen in Figure 2. There are no ties from the brickwork into the timber floor which increases the slenderness of the wall which increase the likely out of plane collapse.

Figure 2 URM wall – No ties at floor or roof level

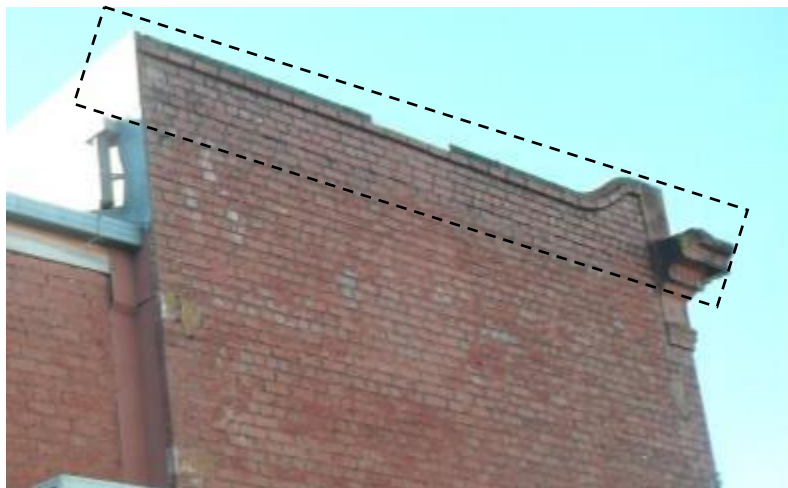
The parapet and front façade are unrestrained which poses an immediate risk of collapse onto the street front though lateral loading situations. The taller and thicker the parapet the higher the period, therefore, a larger displacement demand would occur due to the thickness of this ornate façade. Cantilevered parapets are also likely to fail in shear at the parapet base especially if a damp proof course (DPC) membrane has been used at the parapet base. This is shown in Figure 3.

Figure 3 URM unrestrained damaged parapet

As previously discussed in Section 3.2, the heavy damaged parapet is unrestrained and likely to have large displacements in an earthquake. This could fall out of plane onto the street frontage which is likely to endanger the public safety.

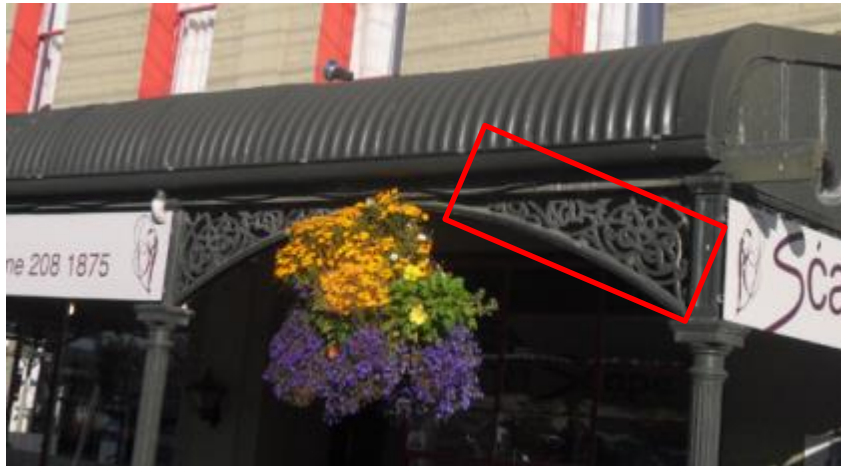
The verandah has deteriorated since its initial construction. The 'hauches' shown in Figure 4 had to be removed as they became loose and the bolt fixings had completely rusted through. These

haunches weighed approximately 50kg each and would cause irreplaceable damage if they were to fall and had to be removed. The bottoms of the posts supporting the verandah have been covered by the overlaid tarmacadam which has prevented drainage out the bottom as originally designed. This has caused the posts to rust and are beyond repair in places.

Figure 4 Haunches have been removed

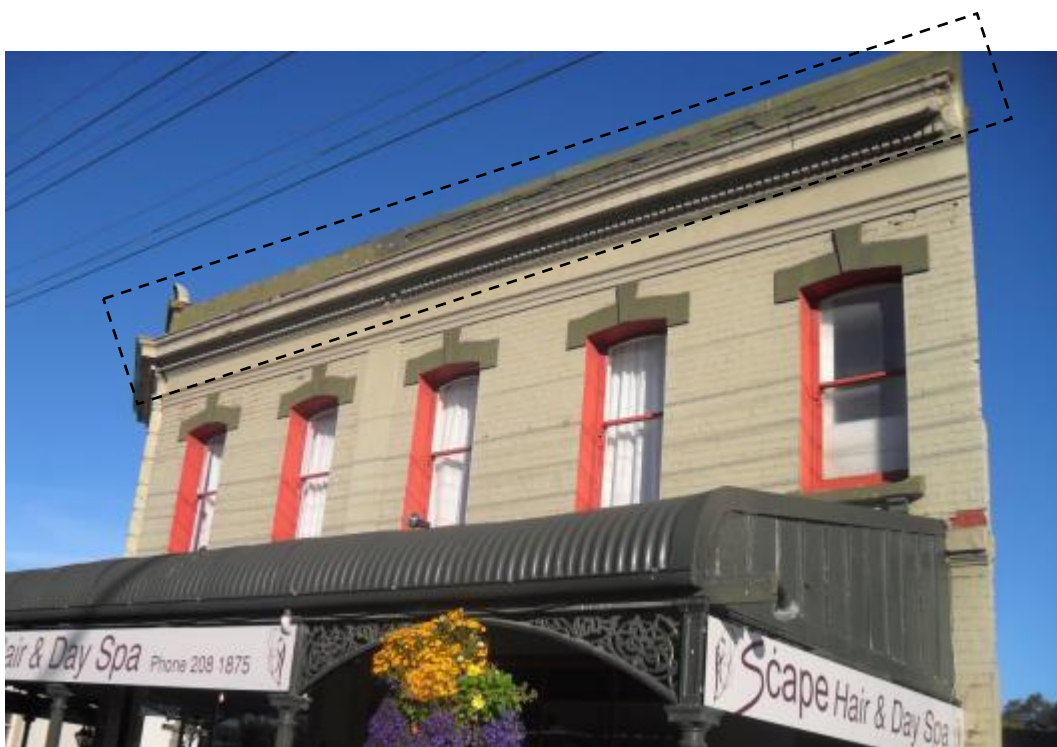
Figure 6 Damaged parapet

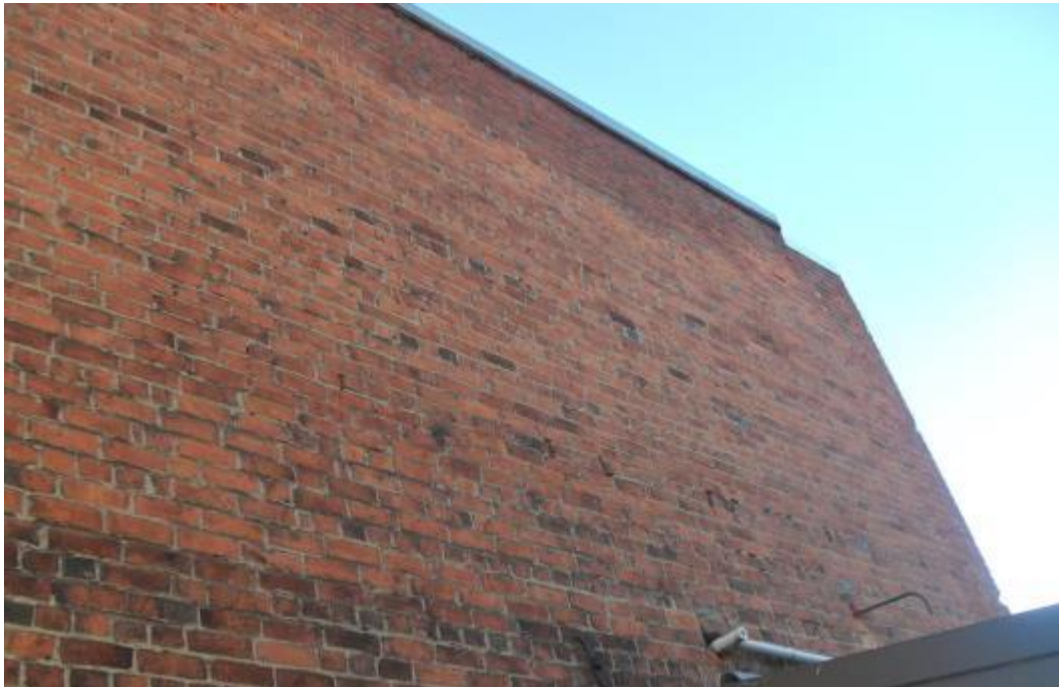
Figure 7 Damaged external URM wall

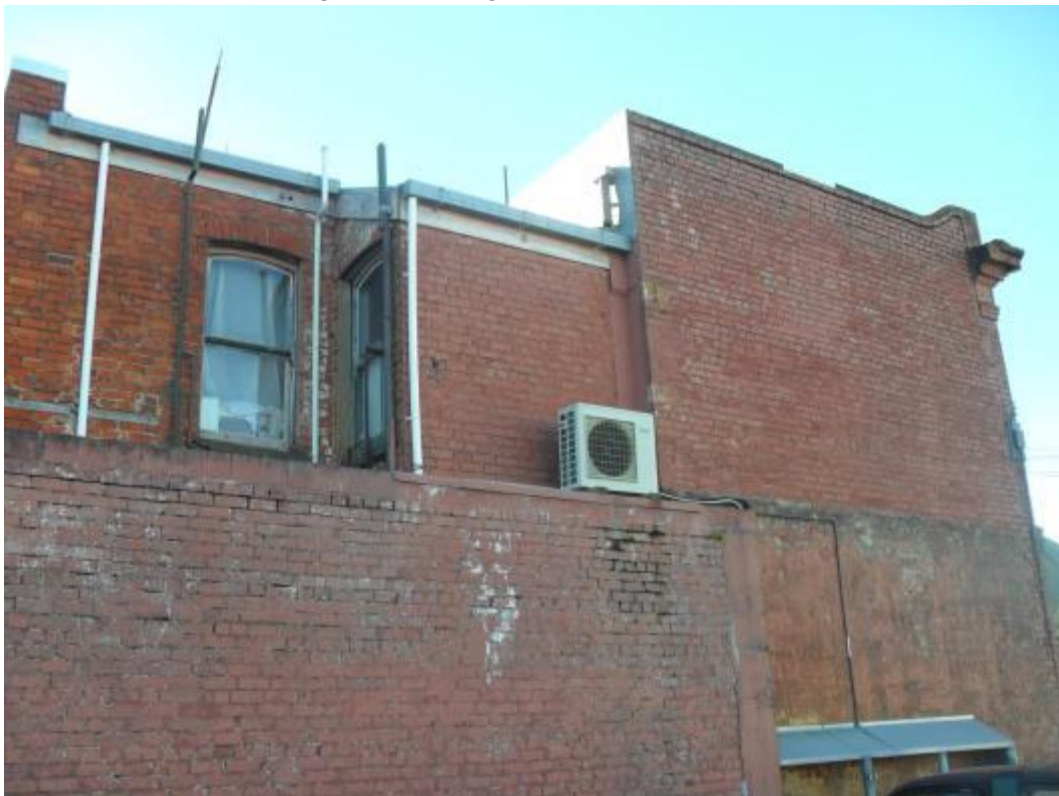
Figure 8 Damaged URM wall, various changes in shape of structure
